# Effect of ePTFE sintering post processing steps on surface quality and pitting corrosion behavior of NiTi stents

Behnam Aminahmadi, Navjeet Gill, Harshad Paranjape,  
Pahul Singh, *Craig Bonsignore*

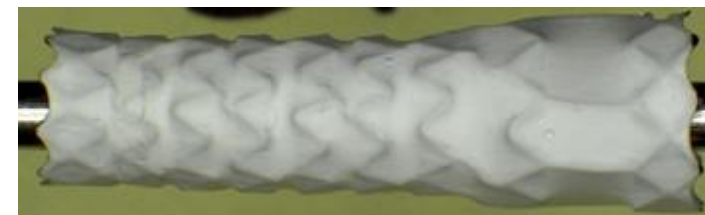
### S.S. Frames:

- Crimped on balloon delivery system
- ePTFE can radially expand to accommodate plastic deformation

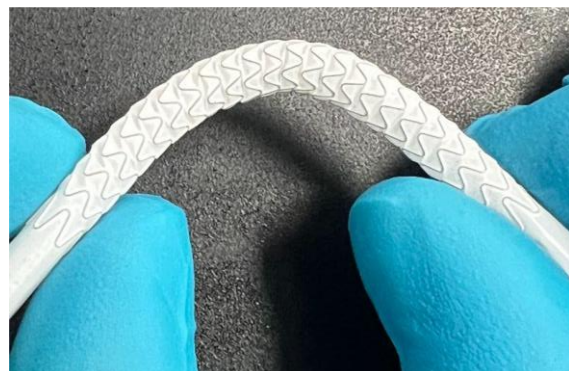
### Nitinol Frames:

- Sheathed in a delivery system
- Flexible ePTFE that accommodates bending

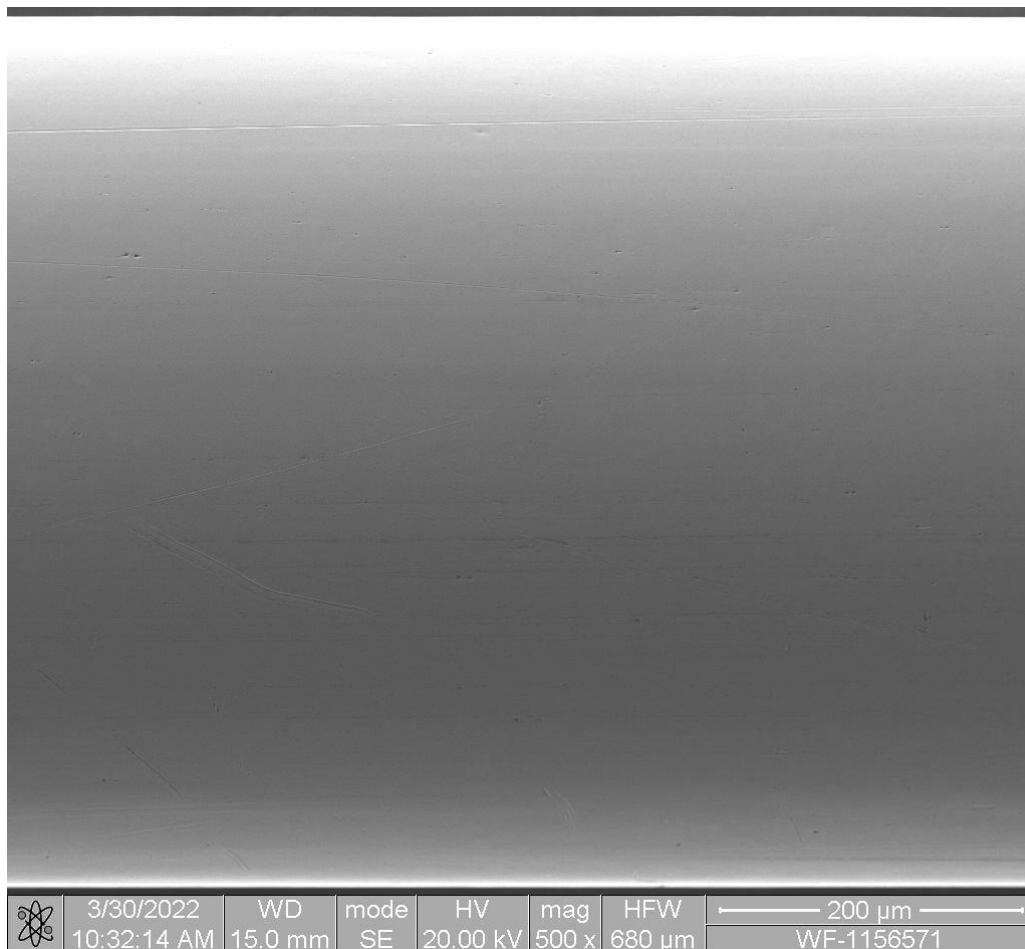
# 1. As EPed- wire- SEM surface study after heat treatment and etch/electropolish steps

- SEM characterization of wire after EP process showed a well polished surface.
- No sign of any surface defects/ pitting was observed.

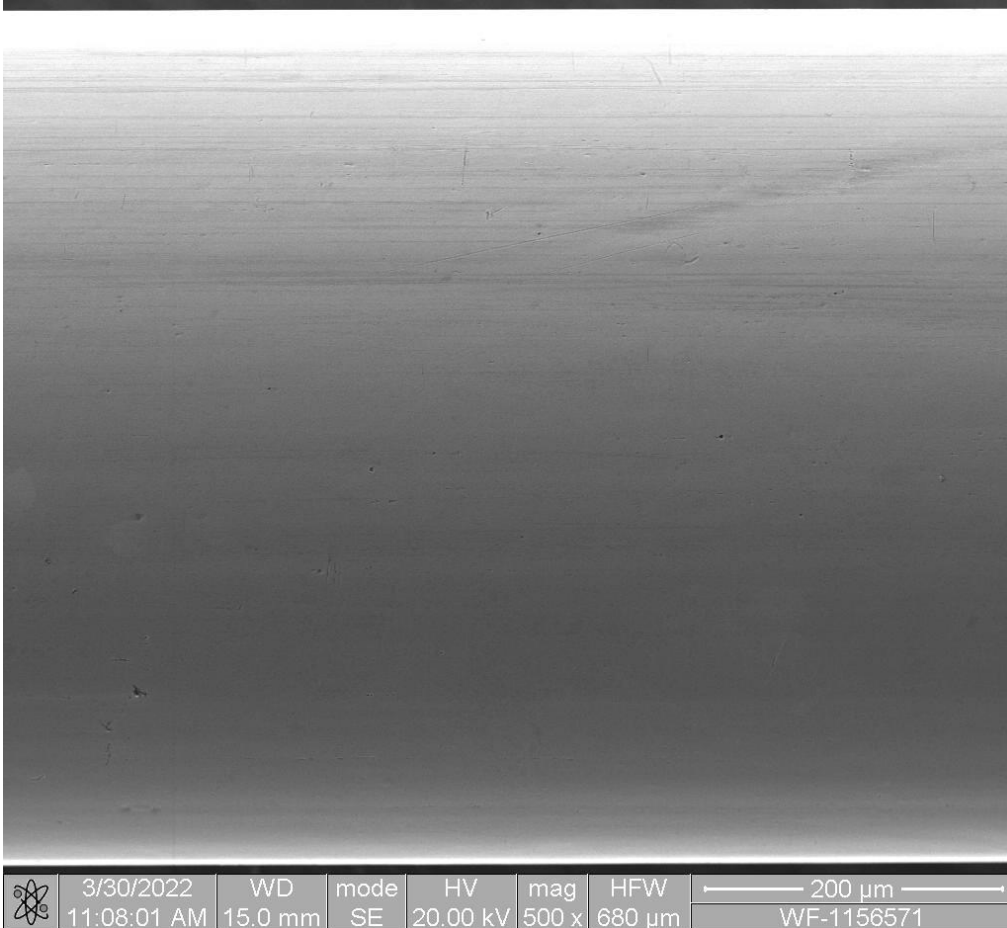
# 1. As EPed- wire- SEM surface study after corrosion test after heat treatment and etch/electropolish steps

- SEM characterization of as- EPed wire after corrosion testing showed similar polished surface as before corrosion testing.
- No sign of any surface defects/ pitting was observed.

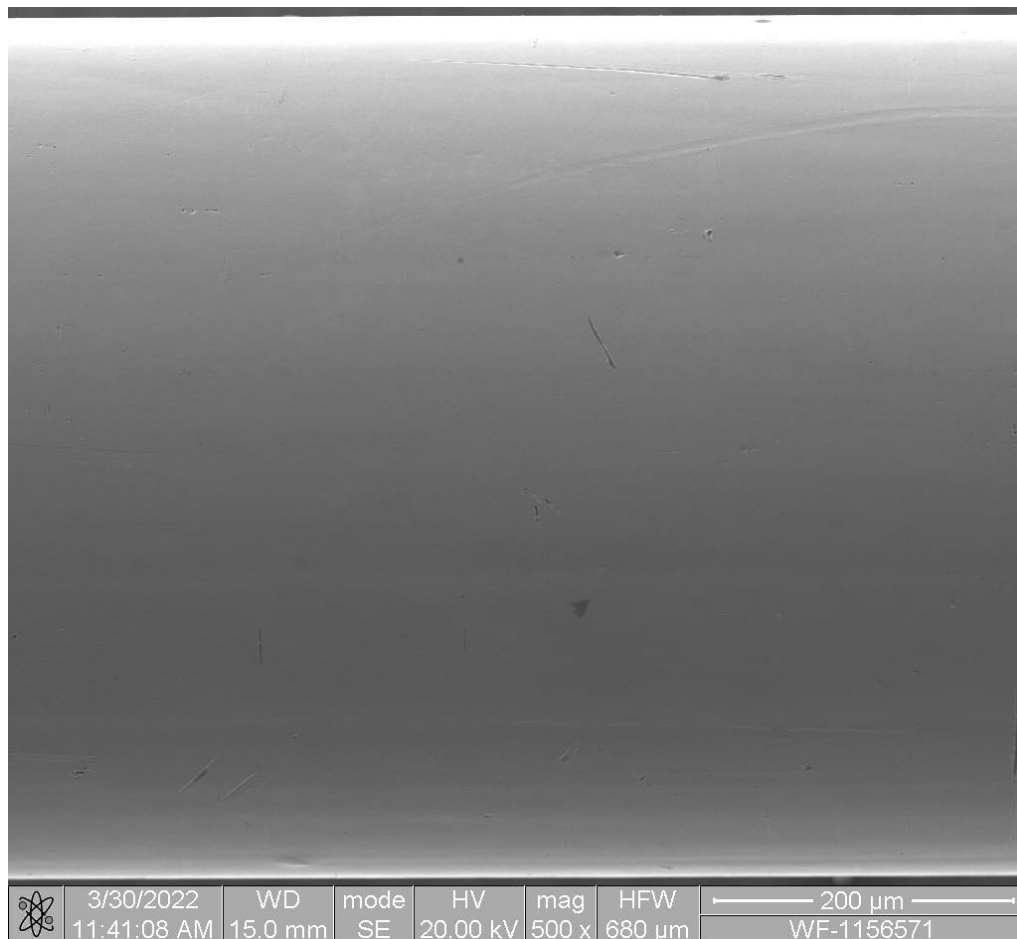
## 2. As sintered- wire- SEM surface study

after heat treatment of EPed wire at 360 C for 10 min in air furnace

- Heat treatment at 360 C for 10 min did not show any significant effect on the surface of the wire
- No sign of any surface defects/ crack was observed.
- The color of the wire turned to light gold after sintering heat treatment

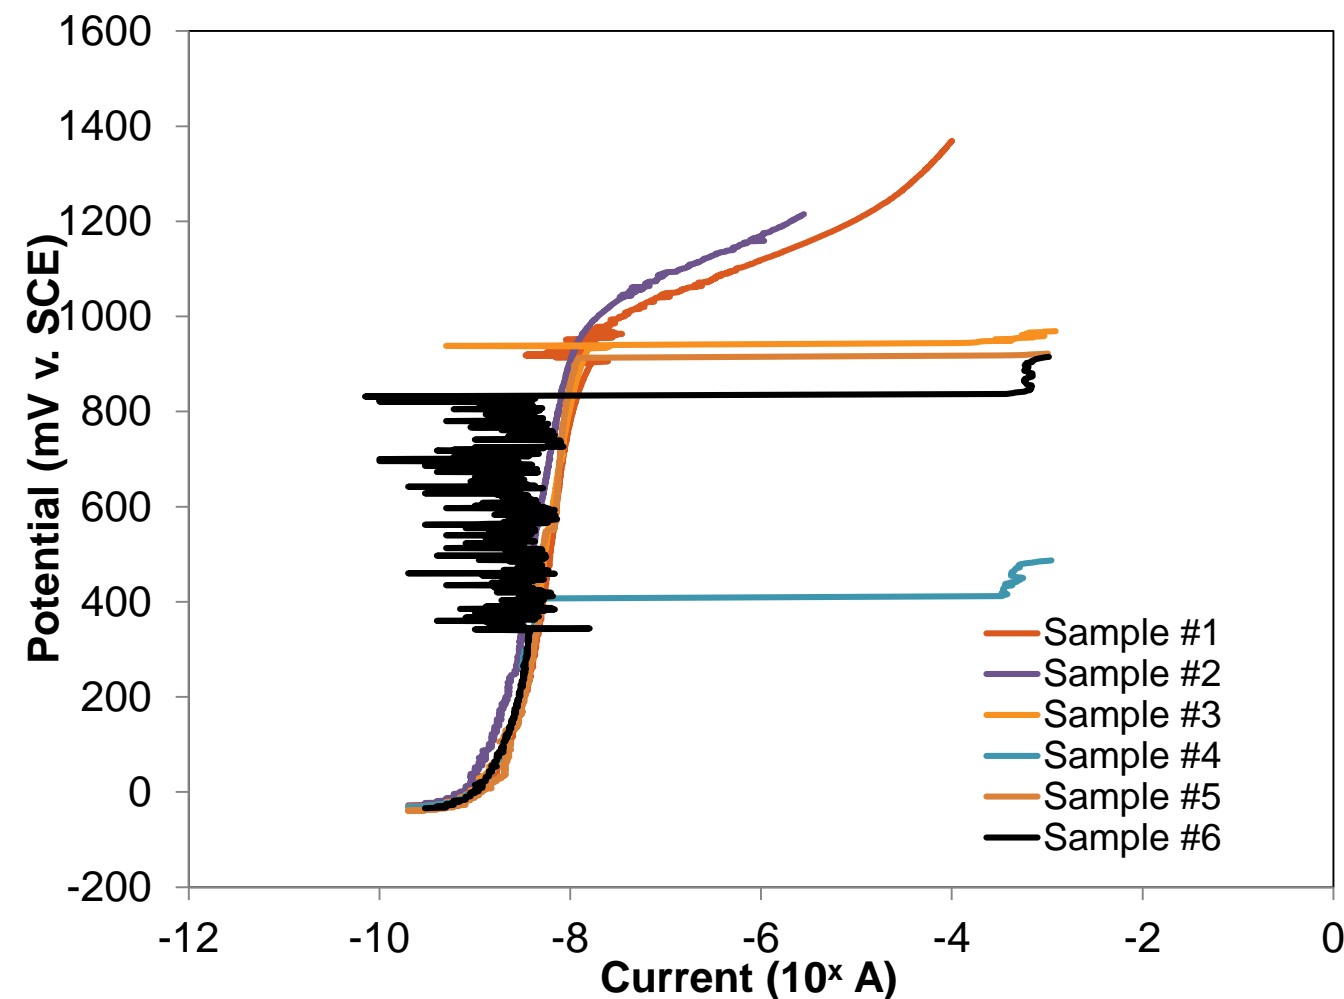
## 2. As sintered- wire- Potentiodynamic corrosion test

after heat treatment of EPed wire at 360 C for 10 min in air furnace

Sample #	$E_r$ (mV v. SCE)	$E_b$ (mV v. SCE)	$E_{ox, ev}$ (mV v. SCE)
1	-37	n/a	983
2	-26	n/a	963
3	-31	933	n/a
4	-30	407	n/a
5	-39	913	n/a
6	-32	832	n/a

- 2 out of 6 as-sintered wires reached Oxygen evolution, however break down potential were high and one of the samples showed 407 mV break down potential

- Post processing heat treatment during ePTFE cover, slightly degrades the potentiodynamic corrosion properties of NiTi wire.
- Lowest breakdown potential was 407 mV which is still higher than accepted criteria for NiTi devices ( 300 mV)
- Applying 8 % strain ( stimulating the crimping procedure) did not have any effect on corrosion properties of the device

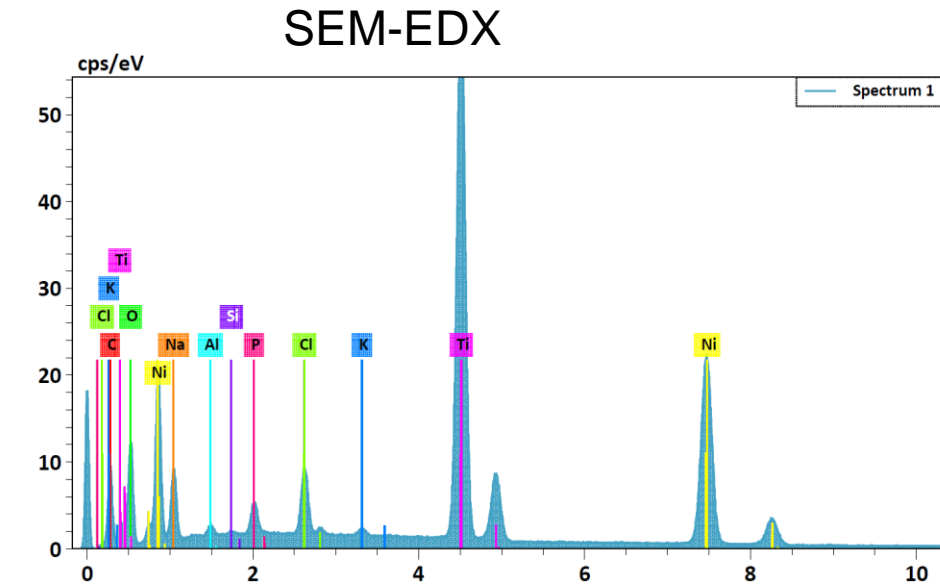
## 2. As sintered- wire- SEM surface study- after corrosion test after heat treatment of EPed wire at 360 C for 10 min in air furnace

Sample #6 ,  $E_b = 832$  mV

- Pitting region was characterized using SEM/EDX techniques

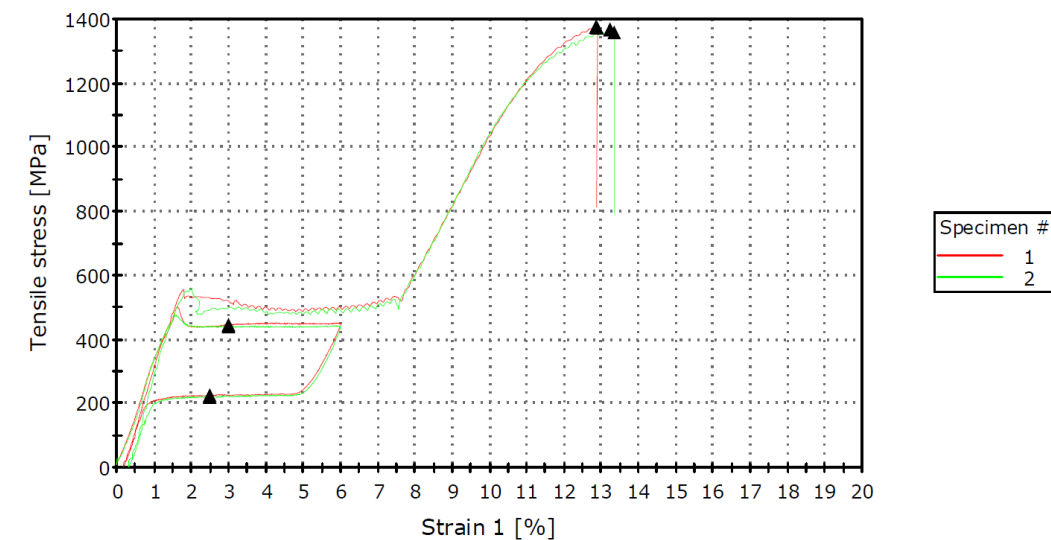
As -Eped+ 360 C for 10 min

Specimen label	UPS @ 3% [MPa]	LPS @ 2.5% [MPa]	UTS [MPa]	Elr [%]	Elu [%]	El at Break [%]	Comment
1	Test1	448	228	1376	0.0	12.8	12.9	OD= .56mm
2	Test2	443	223	1368	0.3	13.2	13.3	OD= .56mm
Mean		445	226	1372	0.2	13.0	13.1	
Standard deviation		4	4	6	0.2	0.3	0.3
