In-vitro to *In-vivo* Correlation of Corrosion in Nitinol Cardiovascular Stents

[1]Office of Science and Engineering Laboratories; FDA Center for Devices & Radiological Health
[2]Confluent Medical Technologies

May 19, 2017

SMST 2017

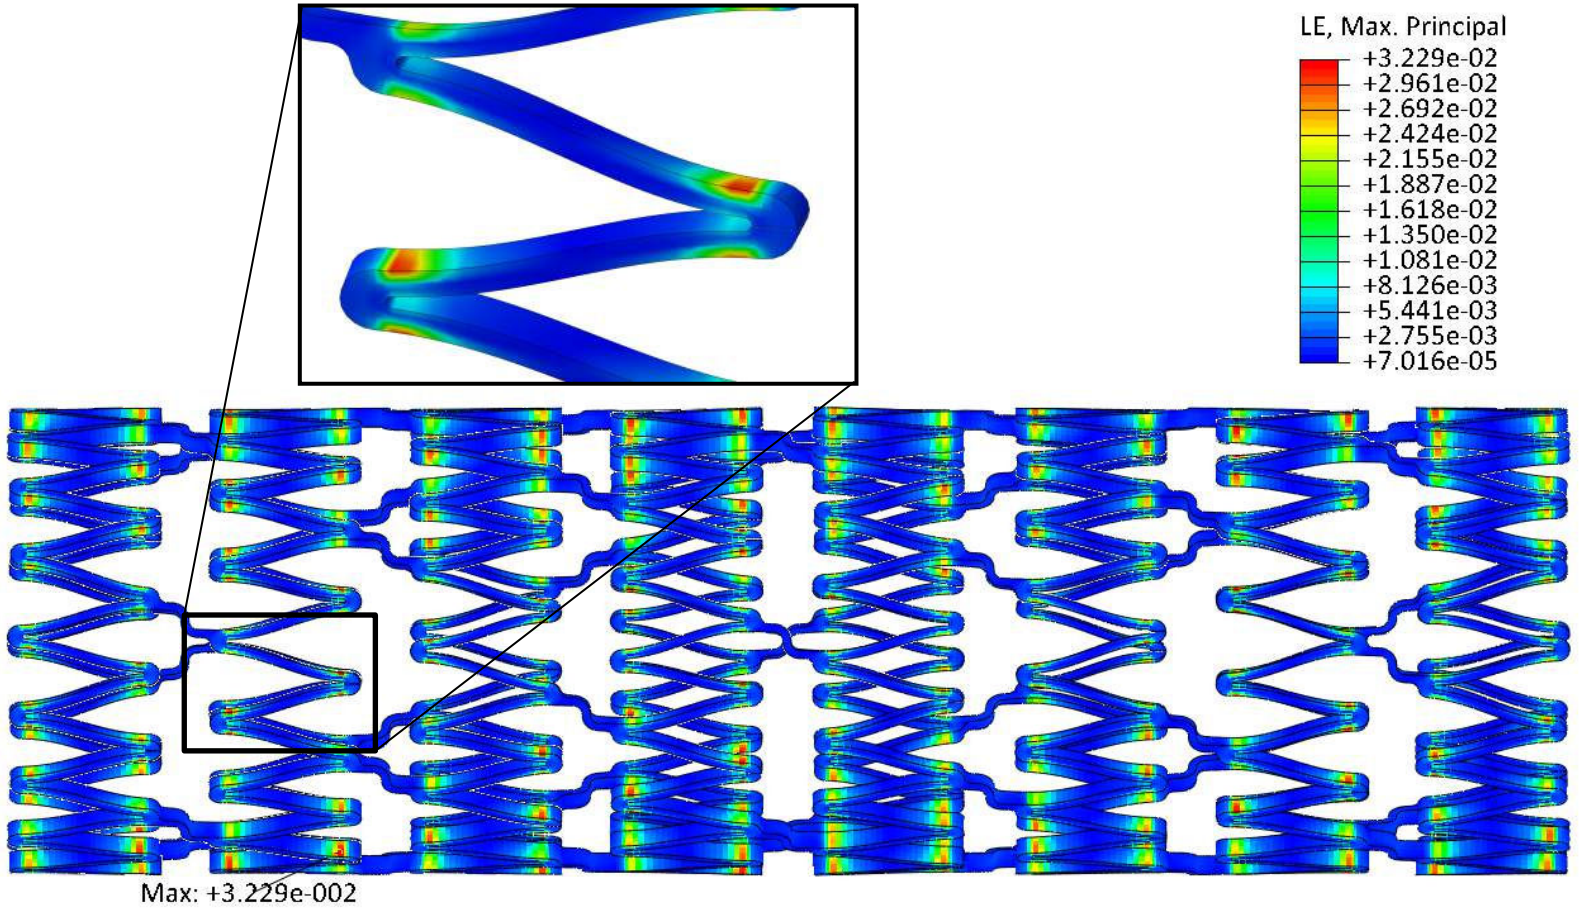
OSS Stent FEA – Crimping & Deployment

→ High strain regions at the apex of V-struts

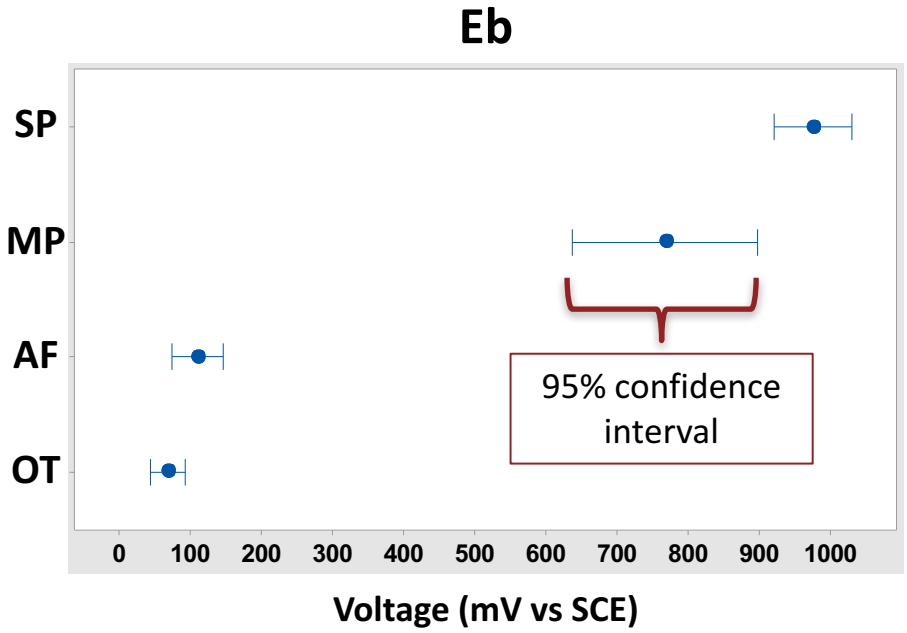
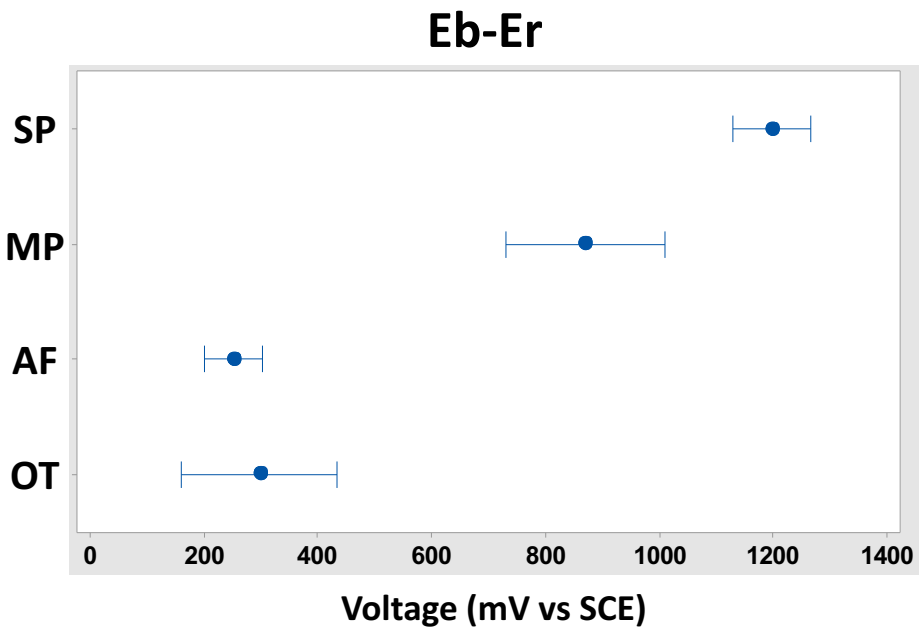
ASTM F2129 Results

SP	MP	AF	OT
E_r (mV)	-224 ± 112	-103 ± 65	-141 ± 44	-230 ± 178
E_b (mV)	975 ± 94	767 ± 226	111 ± 63	68 ± 29
E_b-E_r (mV)	1199 ± 118	870 ± 240	252 ± 90	297 ± 165

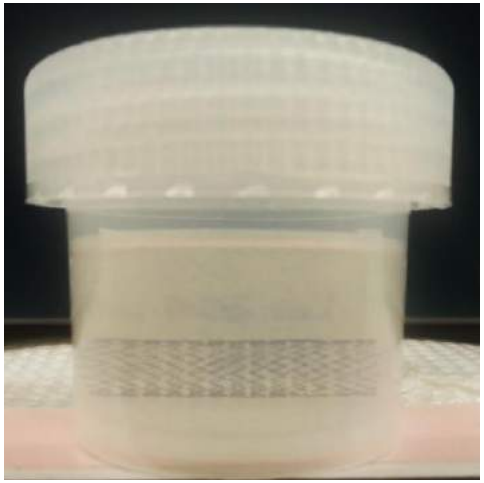
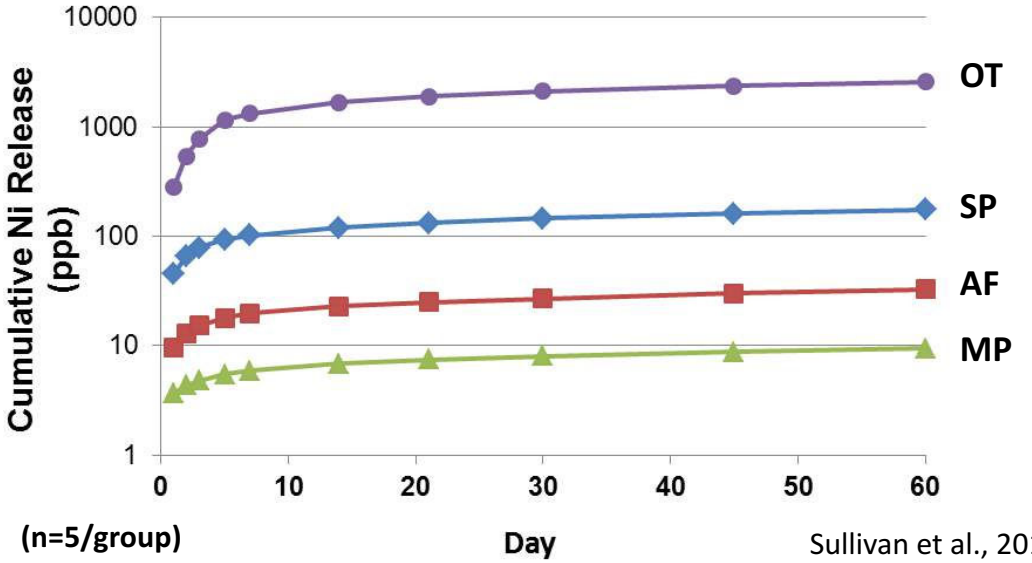
Nickel Leach Testing and Results

- OT, AF, SP, and MP stents (8 X 30mm) immersed in PBS at 37C
- Stents crimped prior to testing
- 10 time points: Day 1, 2, 3, 5, 7, 14, 21, 30, 45, 60
- Ni release: OT > SP > AF > MP for all time points (*$p \leq 0.001$)
- ASTM F2129 breakdown potentials not correlated to Ni release

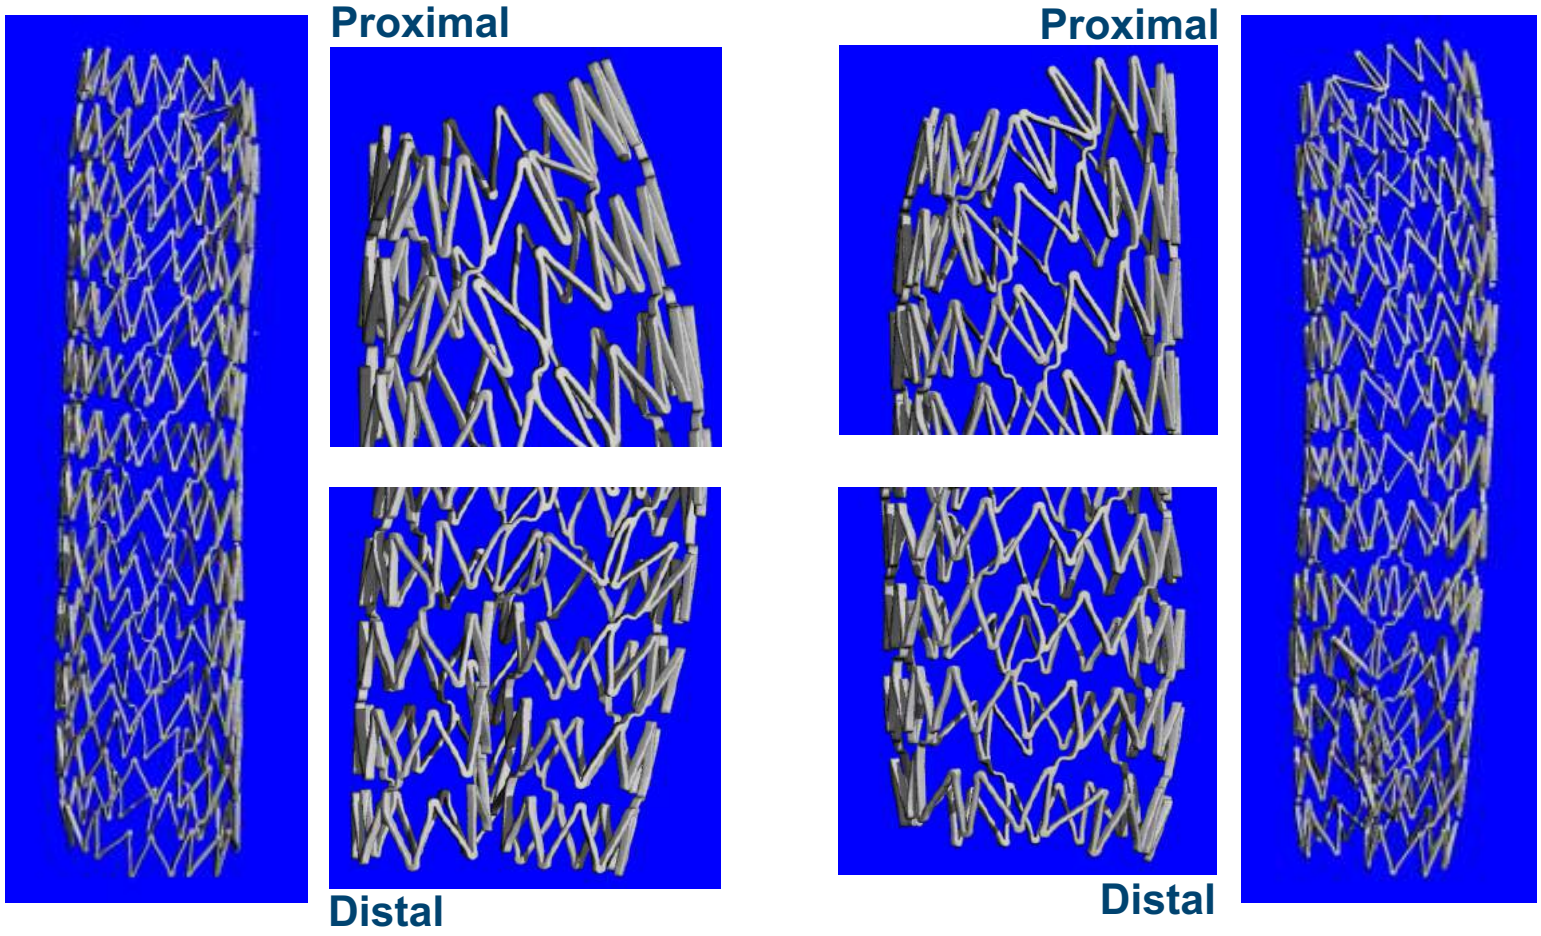
In-Situ Imaging

→Deformation, but no fractures observed in explants

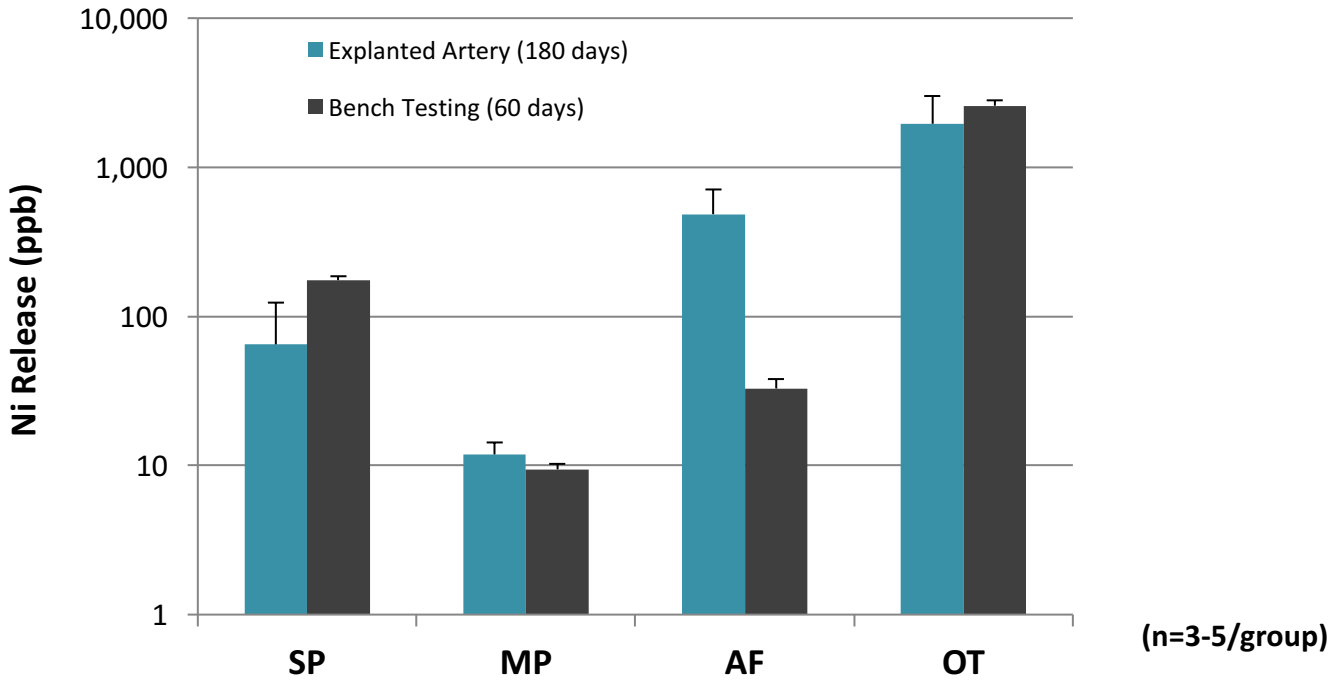
Explanted Artery Nickel

→ Artery nickel: OT > AF > SP > MP

→ Explanted artery Ni values variable compared to in-vitro results

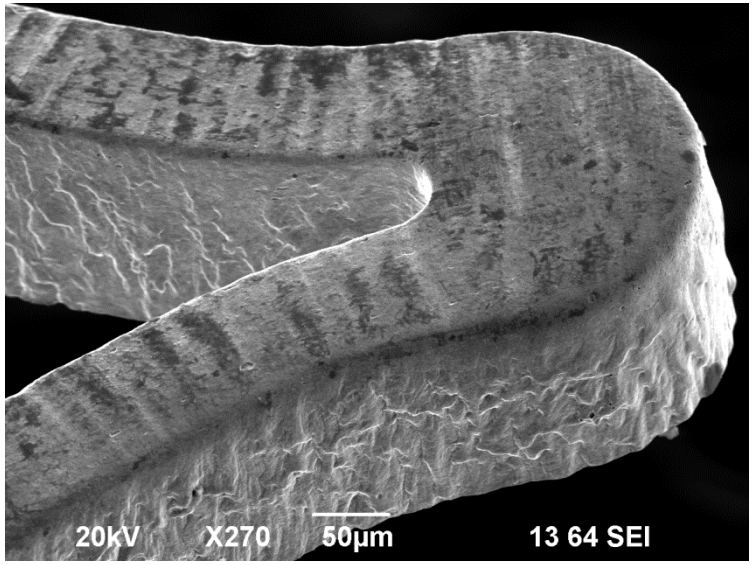
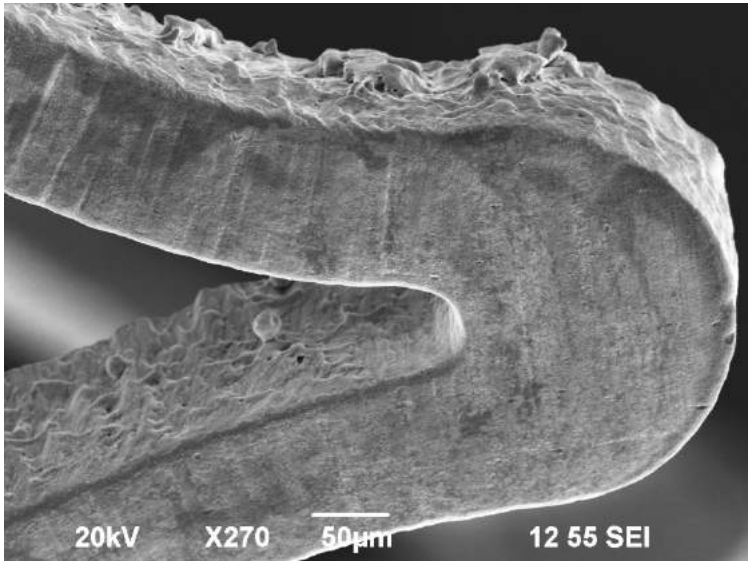
SEM Imaging – Salt Pot (high F2129)

Ni/Ti	n
SP Non-implanted	1.12 +/- 0.06	13
SP Explants	1.13 +/- 0.04	36

→ No corrosion observed in explanted SP stents

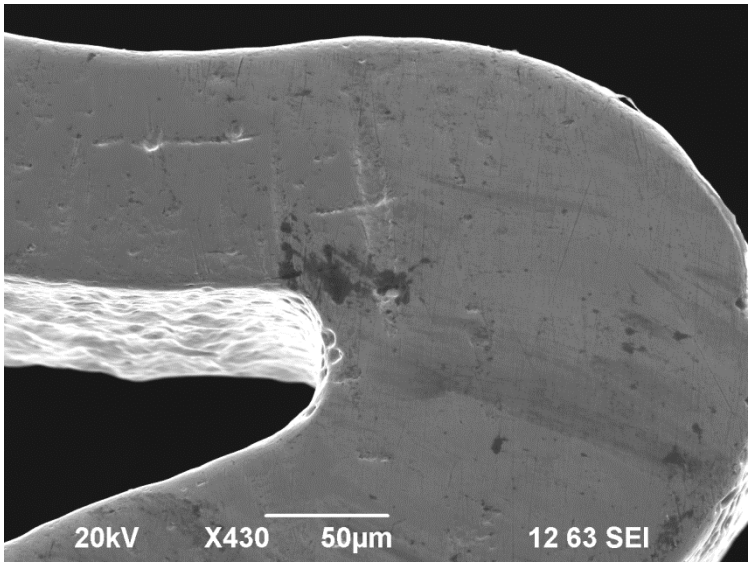
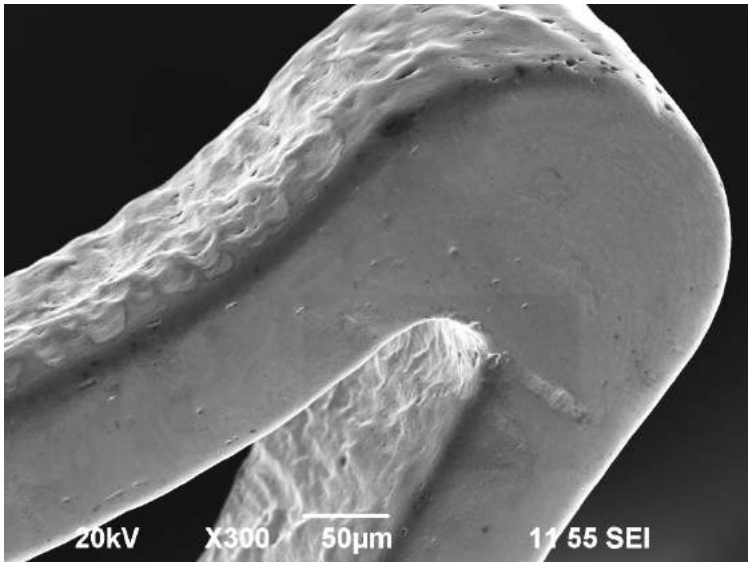
SEM Imaging – Mech. Polish (medium F2129)

Ni/Ti	n
MP Non-implanted	1.11 +/- 0.01	14
MP Explants	1.11 +/- 0.03	47

→ No corrosion observed in explanted MP stents

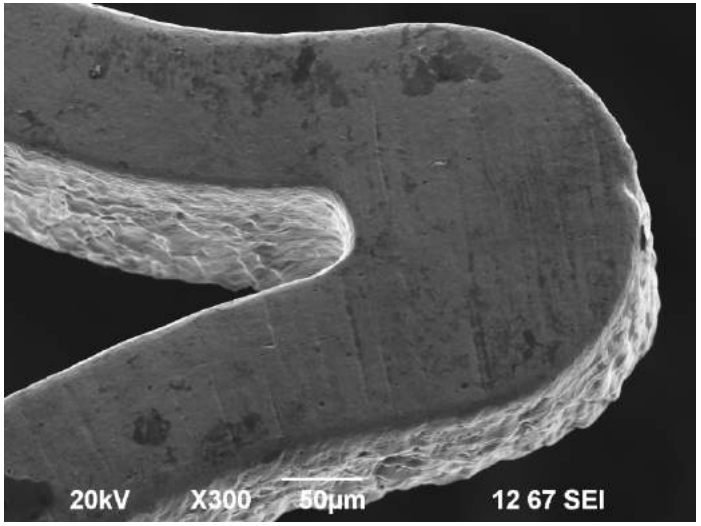
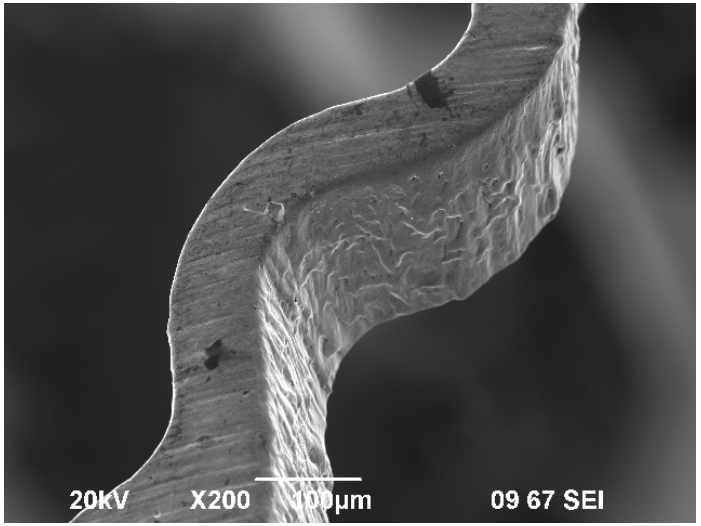
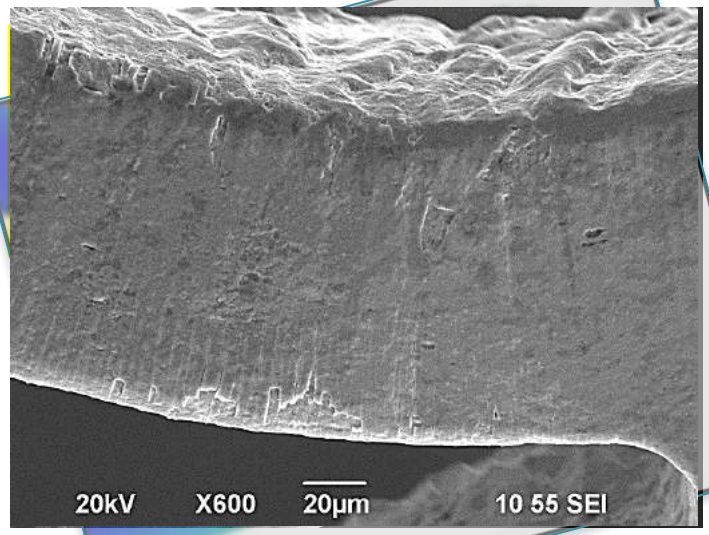
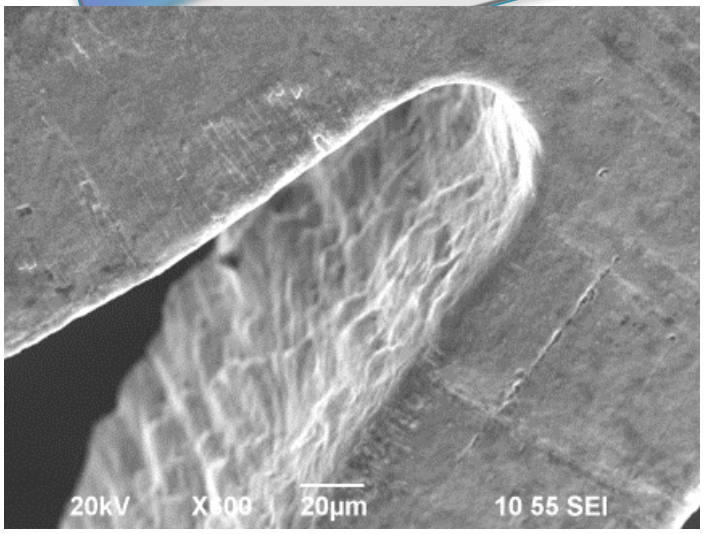
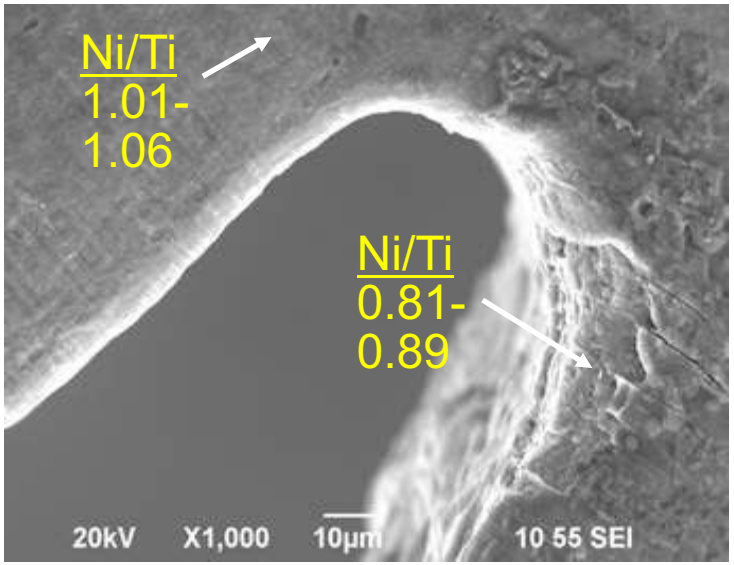
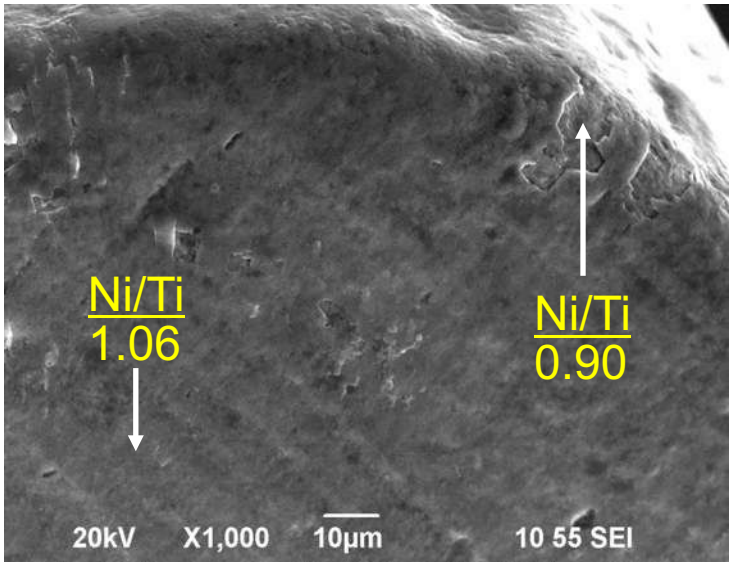
SEM Imaging – Air Furnace (low F2129)

Ni/Ti	n
AF Non-implanted	1.11 +/- 0.02	13
AF Explants - Native Surface	1.08 +/- 0.05	22
AF Explants – Corrosion	0.89 +/- 0.15	24

→ Micro-cracks & corrosion observed in explanted AF stents

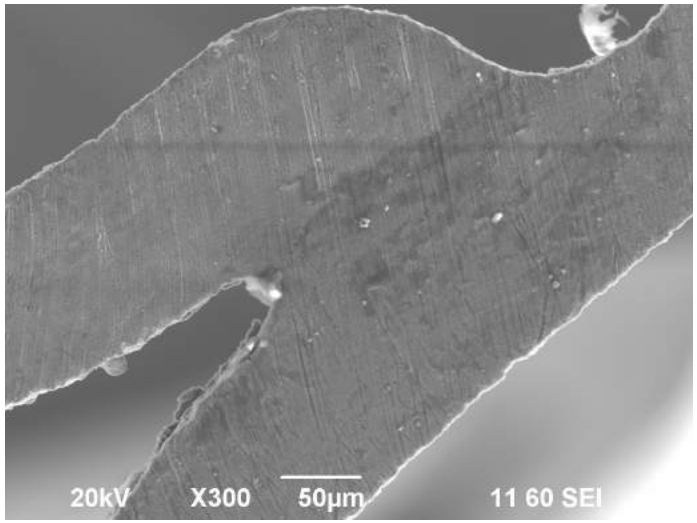
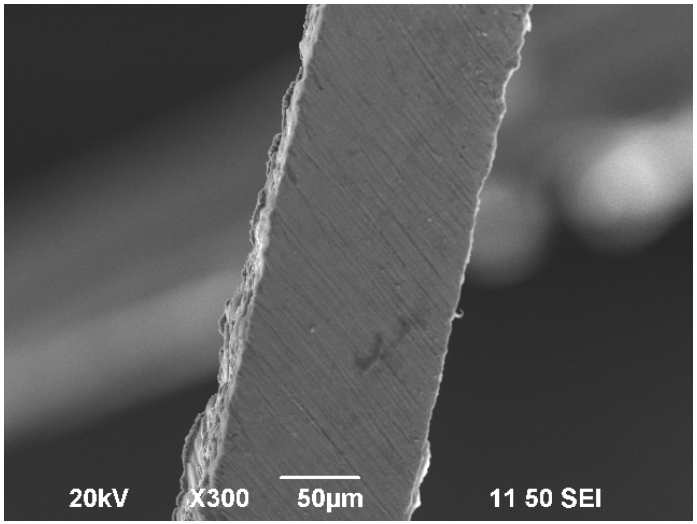
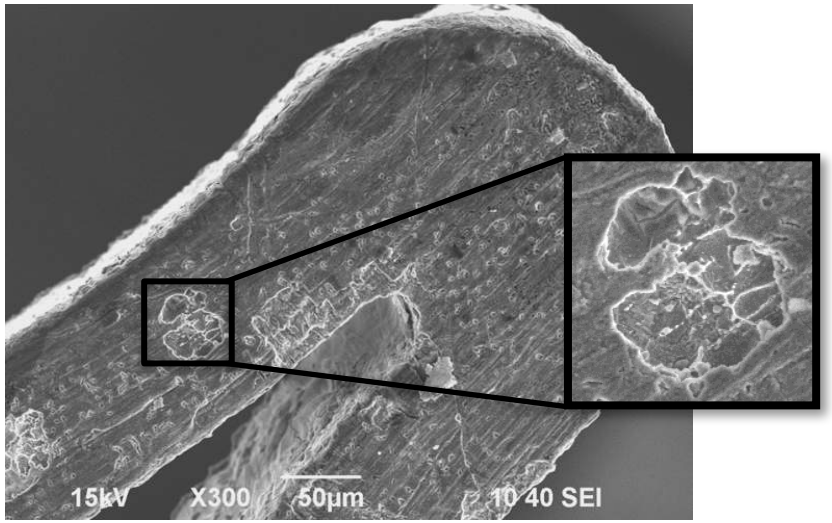
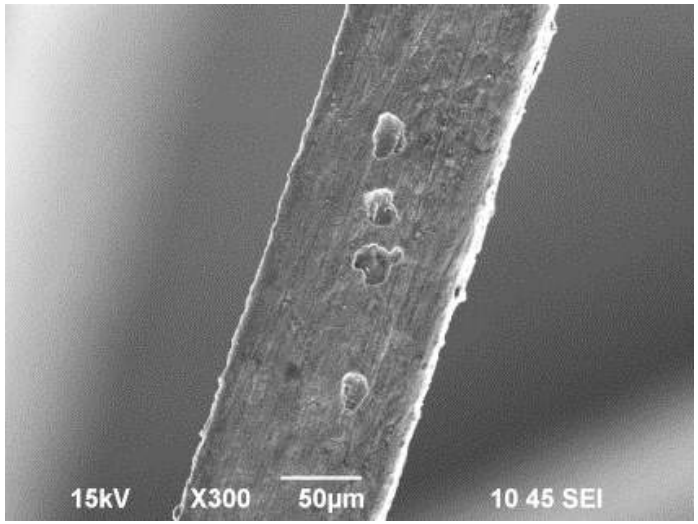
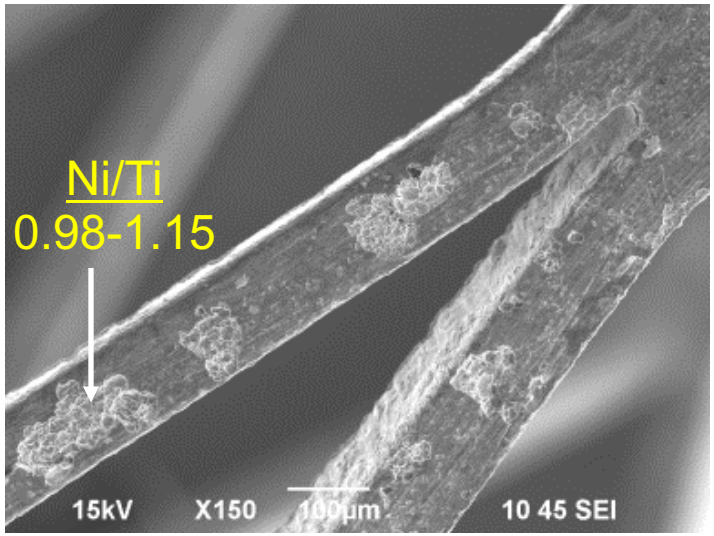
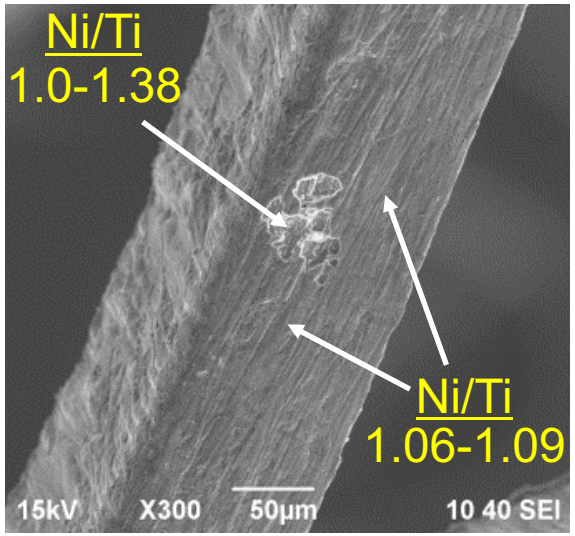
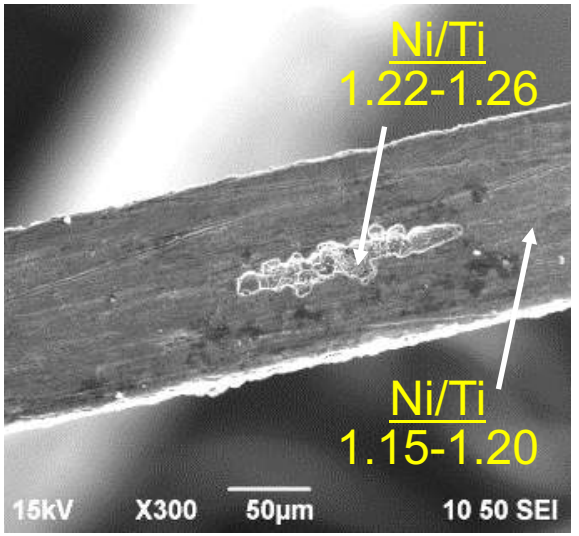
SEM Imaging – Oxidized Tubing (low F2129)

Ni/Ti	n
OT Non-implanted	1.16 +/- 0.10	20
OT Explants - Native Surface	1.05 +/- 0.31	32
OT Explants – Corrosion	1.14 +/- 0.11	59

→ Pitting observed in explanted OT stents

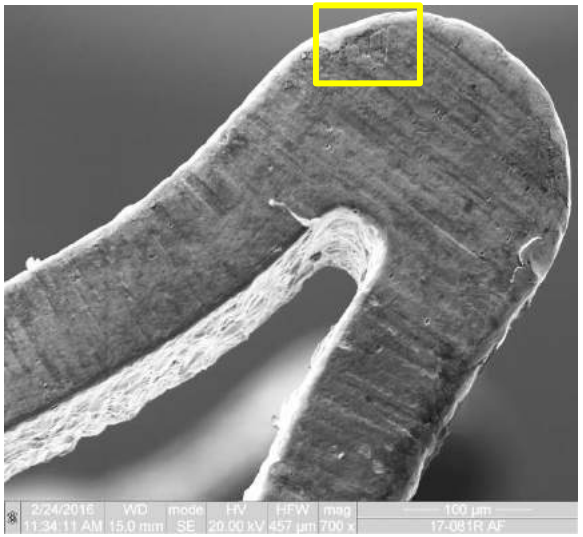
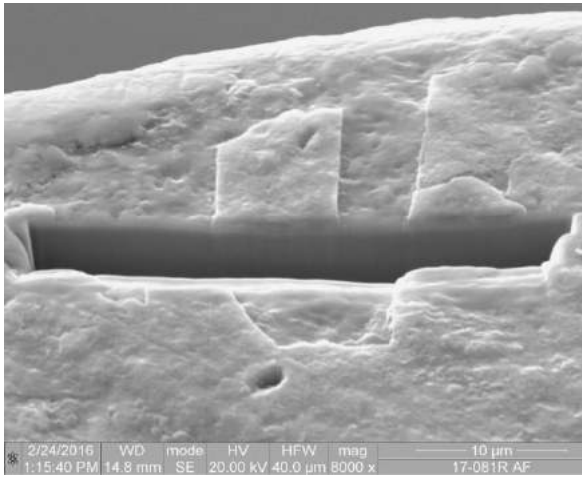
AF Stent

AF→ ~1 micron deep corrosion

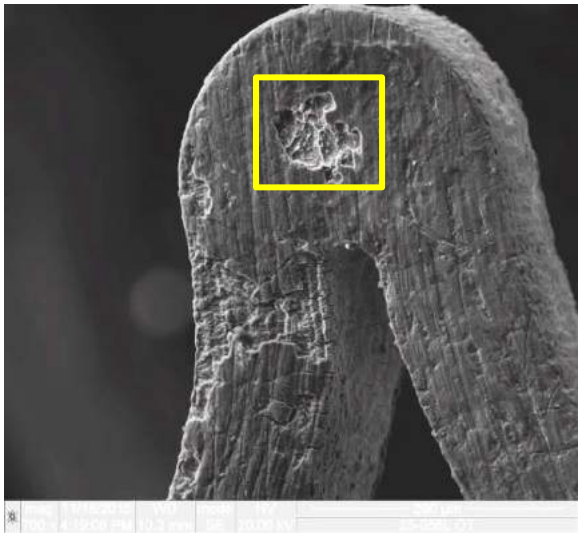
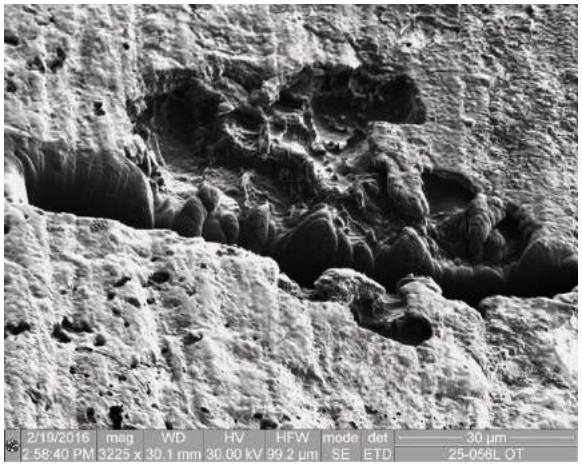
OT Stent

OT→ ~9 micron deep pits

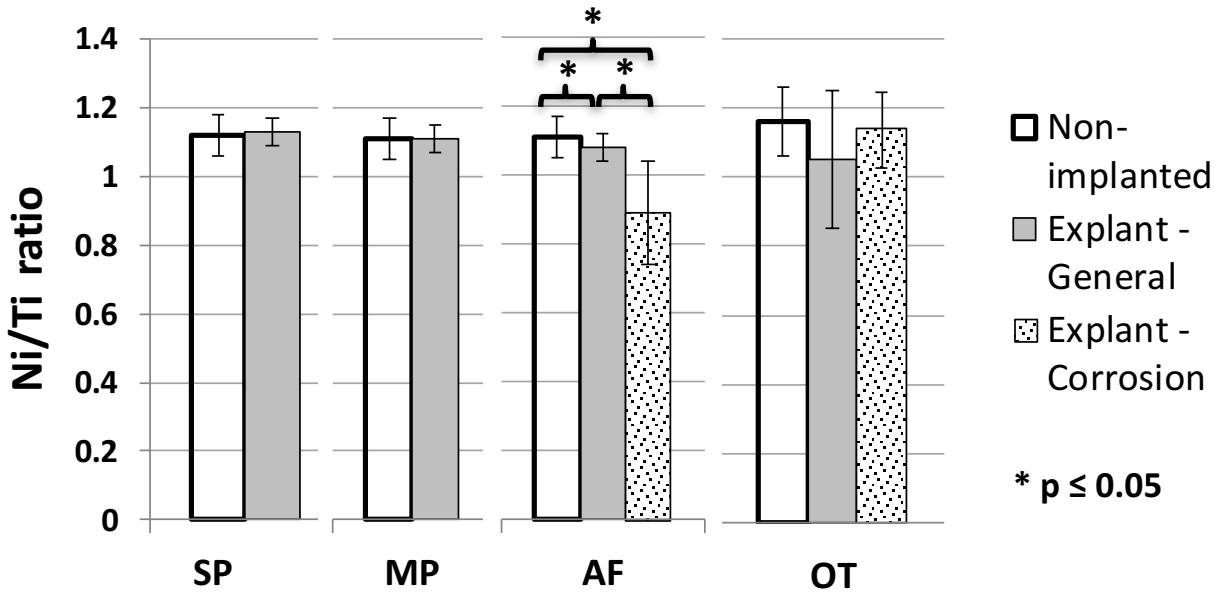
Elemental Analysis Summary

- SP and MP explants: no change in Ni/Ti ratios
- AF explants: sig. lower Ni/Ti ratios in corroded regions
- OT explants: similar Ni/Ti ratios in corroded regions
